**MARYLAND HISTORICAL TRUST
DETERMINATION OF ELIGIBILITY FORM**

Property Name: John Ward Dwelling Inventory Number: WI-678
Address: 501 Christopher Street Historic district: ☐ yes ☒ no
City: Salisbury Zip Code: 21801 County: Wicomico
USGS Quadrangle(s): Salisbury, Delmar
Property Owner: Frances J. McCrorey, et al. Tax Account ID Number: 058112
Tax Map Parcel Number(s): 85 Tax Map Number: 38
Project: Shore Transit Operating and Administrative Facility Agency: Maryland Transit Administration
Agency Prepared By: A.D. Marble & Company
Preparer's Name: Connie Torbeck/Emma Young Date Prepared: 7/31/2008
Documentation is presented in: Wicomico County Land Records, Salisbury, Maryland.
Preparer's Eligibility Recommendation: ☐ Eligibility recommended ☒ Eligibility not recommended
Criteria: ☐ A ☐ B ☐ C ☐ D Considerations: ☐ A ☐ B ☐ C ☐ D ☐ E ☐ F ☐ G
Complete if the property is a contributing or non-contributing resource to a NR district/property:
Name of the District/Property: _____

John Ward Dwelling WI-678

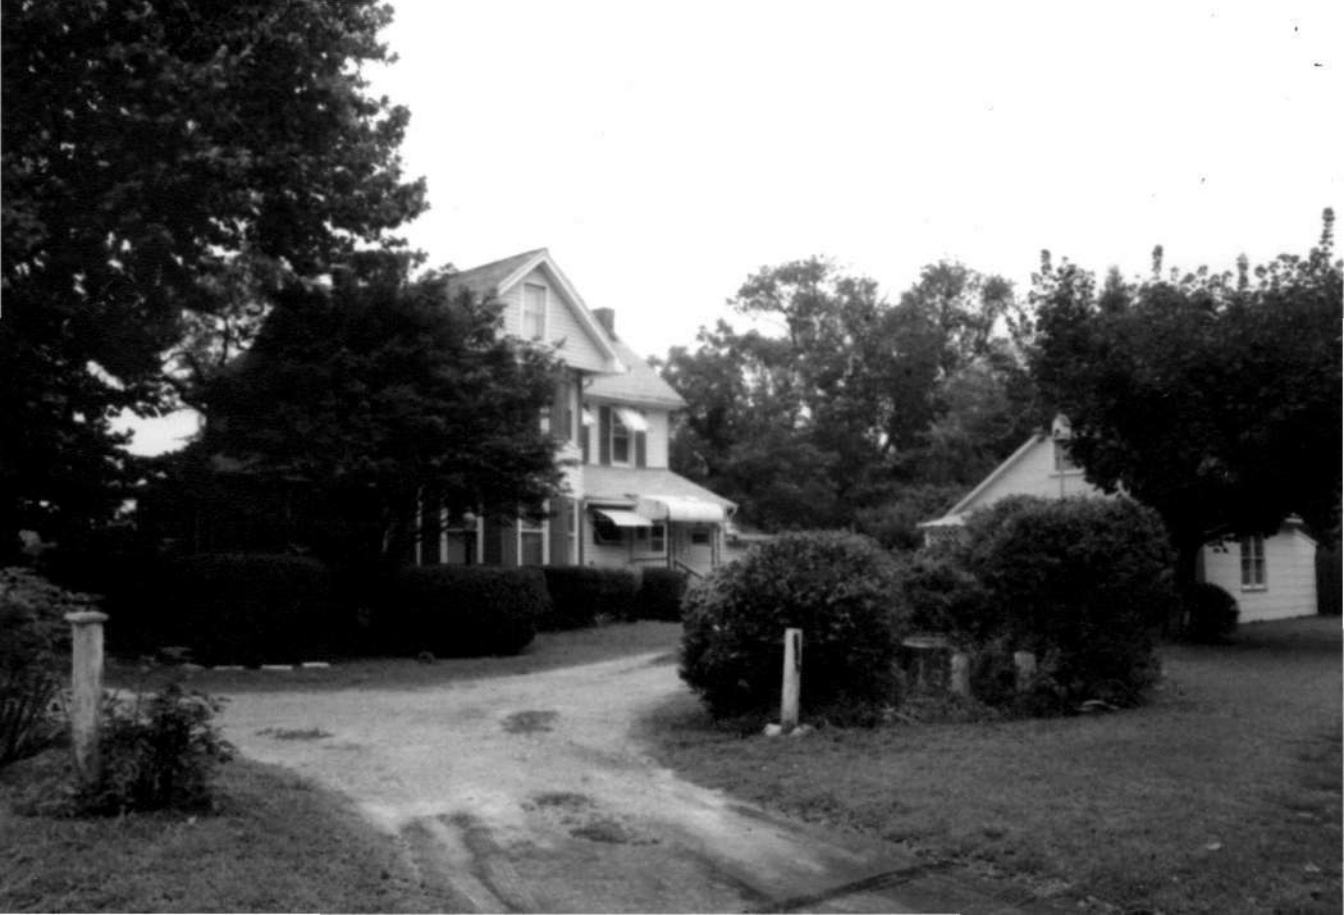
Photo # 1 of 12

Overview of property, looking NE

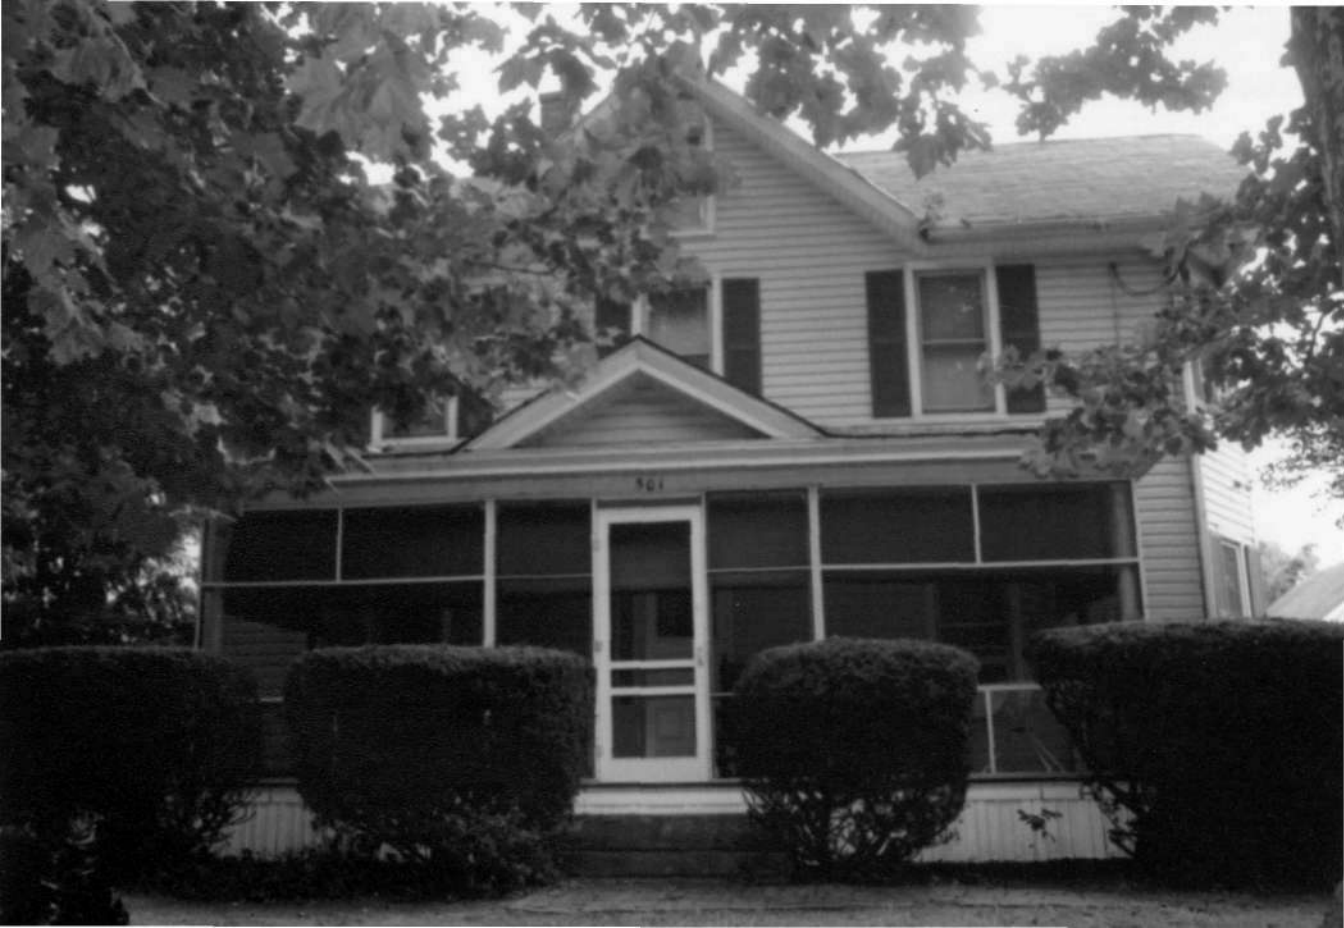
The façade is three-bays wide with a window-door-window configuration in the first story, three symmetrically placed windows in the second story, and a single window in the center gable. The main entrance, consisting of a one-light-over-six-panel door, is sheltered by a screened-in front porch.

Dwelling, west elevation, looking NE
Photo # 2 of 12

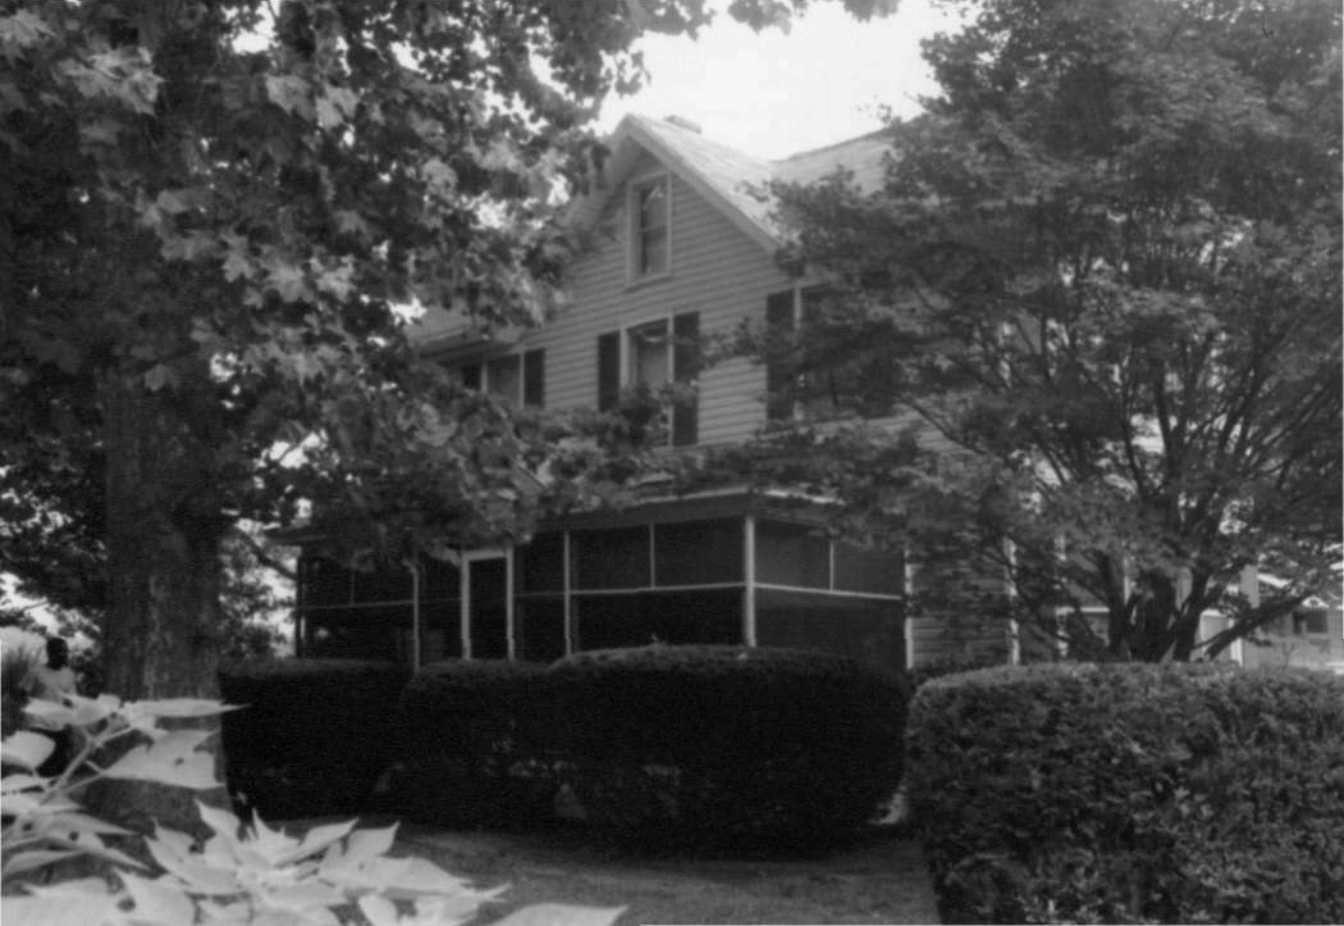
DWELLING, west elevation, looking NE
Photo # 3 of 12

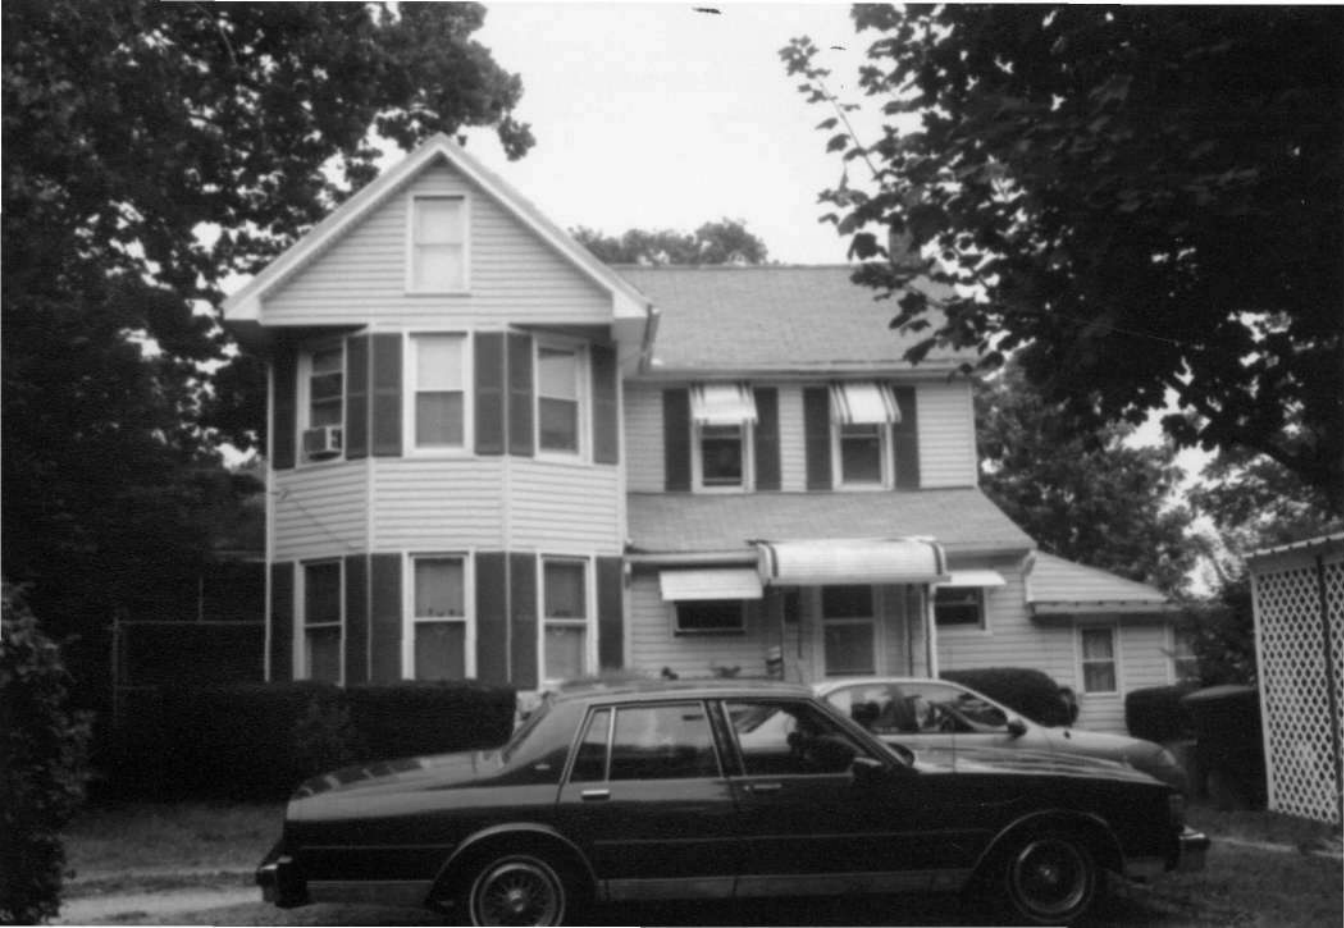
Photo # 4 of 12

The south elevation includes the south walls of the screened-in porch, the main block, the rear ell, the former service porch/kitchen, and the rear entrance porch. The south elevation of the main block consists of a two-story projecting bay capped by a gable. The symmetrical fenestration in the second story of the rear ell are flanked by inoperable louvered, aluminum shutters and capped with aluminum awnings. The former service porch/kitchen is three-bays wide, with a three-light-over-three-panel, wood door flanked by vinyl awning-sash windows that are sheltered by aluminum awnings. The secondary entrance is accessed by a concrete stoop with brick steps and a wooden hand rail. The stoop is sheltered by an aluminum awning resting on scrolled metal supports. The south elevation of the rear entrance porch is lit by two one-over-one light, double-hung, vinyl-sash windows.

Dwelling, south elevation, looking N

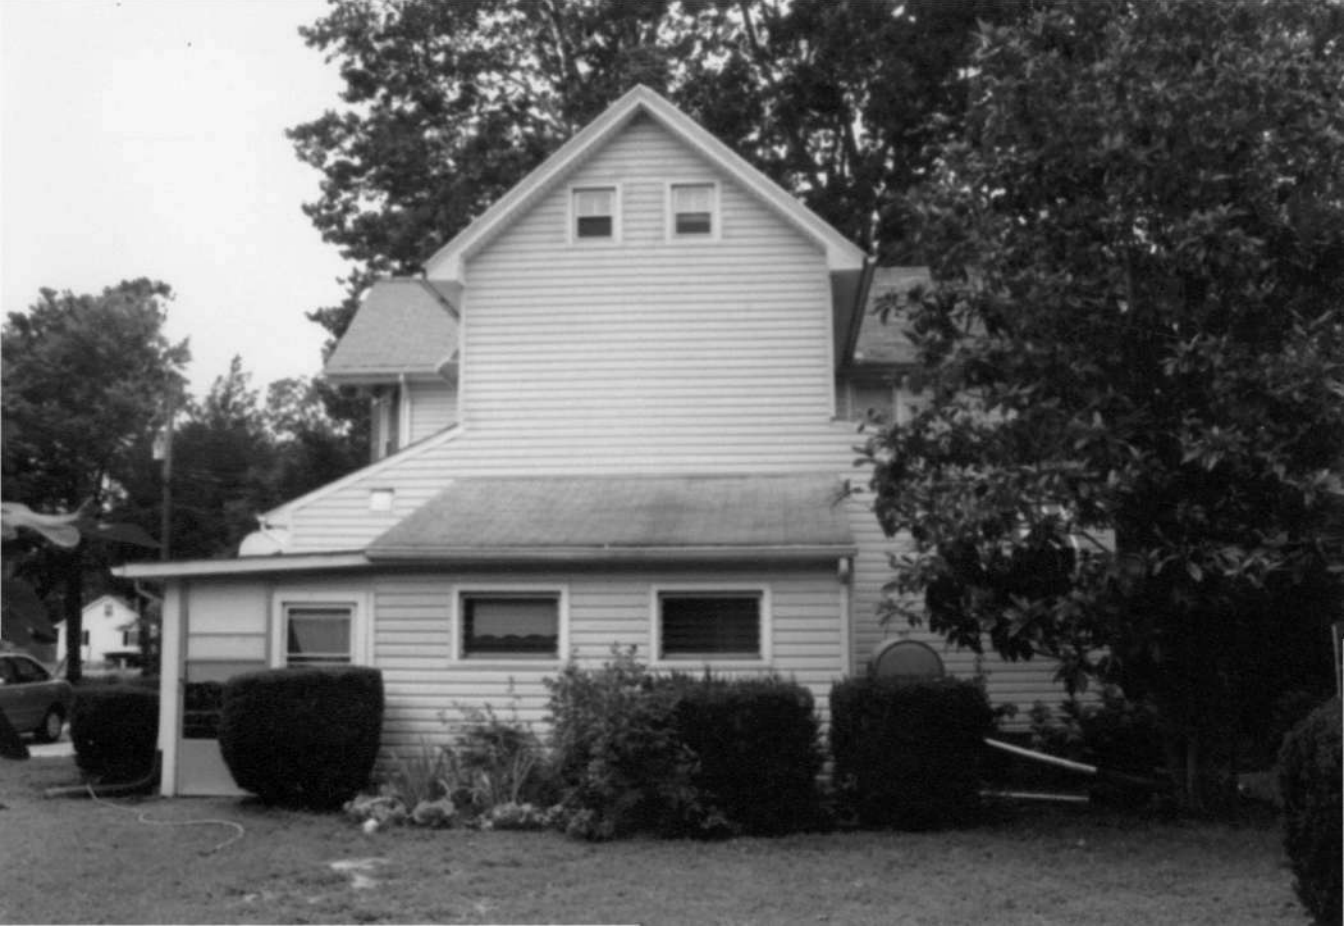
Photo # 5 of 12

The rear/east elevation includes the rear elevations of the main block and rear ell. The ell extends eastward from the approximate center of the main block. The second story of the rear elevation of the main block includes a one-over-one, double-hung sash window in either side of the ell. The first story of the ell is obscured by the rear service porch addition, and no openings exist in the second story. A pair of two-over-one light, wood-sash windows is centered in the gable of the ell. The east elevation of the former service porch/kitchen is largely obscured by the rear entrance porch addition. The entrance porch addition is accessed by an aluminum storm door that is flanked by a one-over-one light, double-hung, vinyl-sash window. A rear service porch addition abuts the north wall of the rear entrance porch addition. This space is lit by a pair of vinyl jalousie windows. The east elevation of the living room addition includes a single one-over-one light, double-hung, vinyl-sash window capped by an aluminum awning.

DWELLING, EAST elevation, looking W

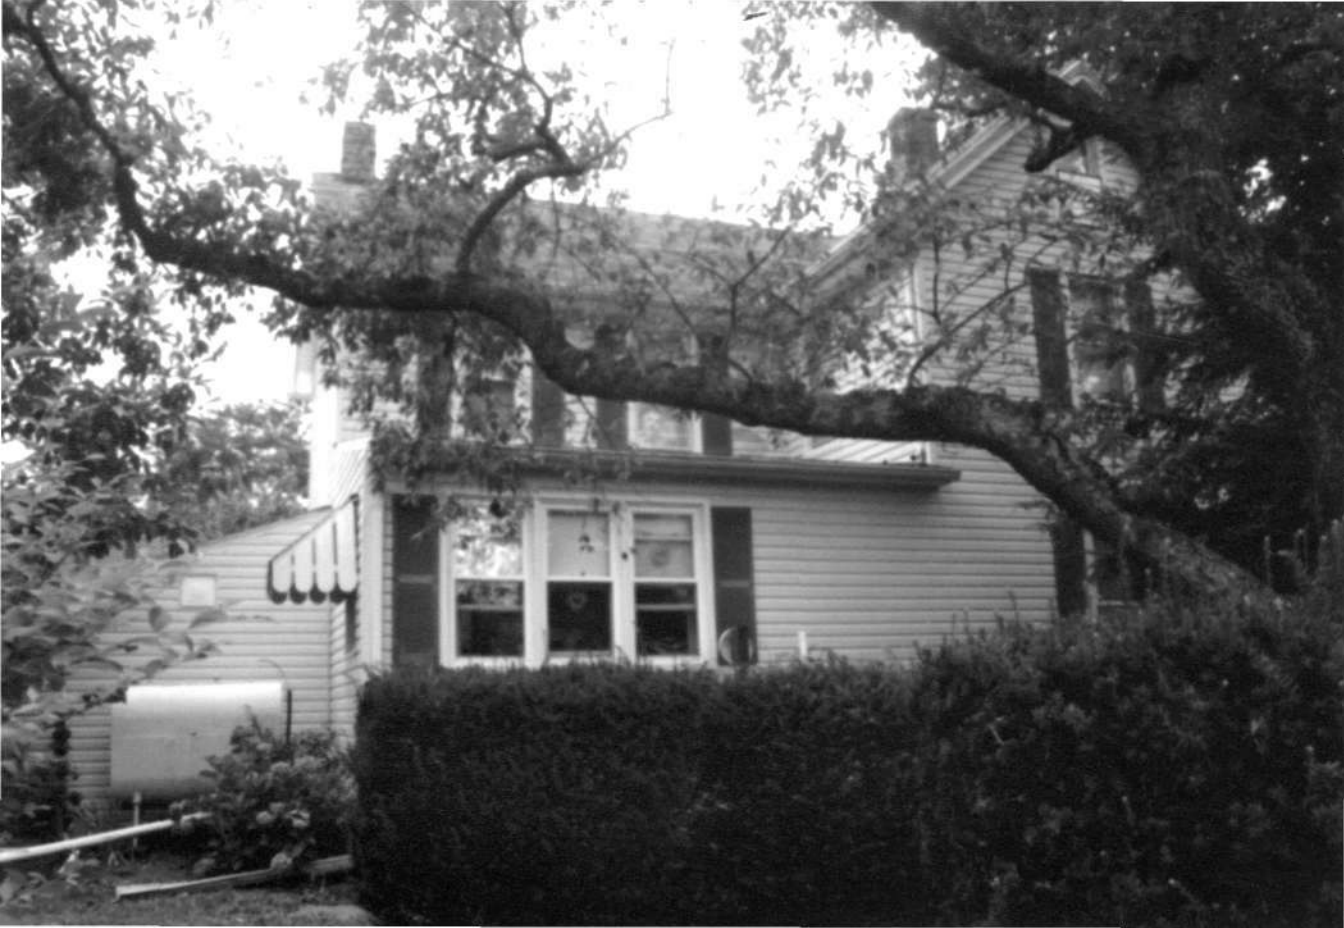
The north elevation of the main block includes a one-over-one light, double-hung, wood-sash window in each story. The first- and second-story windows are covered by aluminum storms and flanked by louvered aluminum shutters. The first story of the rear ell is obscured by the living room addition. The second story is lit by a pair of one-over-one light, double-hung, wood-sash windows with aluminum storms and inoperable louvered, aluminum shutters. The north elevation of the shed-roofed living room addition is lit by tripartite one-over-one light, double-hung, vinyl-sash windows flanked by inoperable louvered, aluminum shutters.

DWELLING, NORTH Elevation, looking SE
Photo # 6 of 12

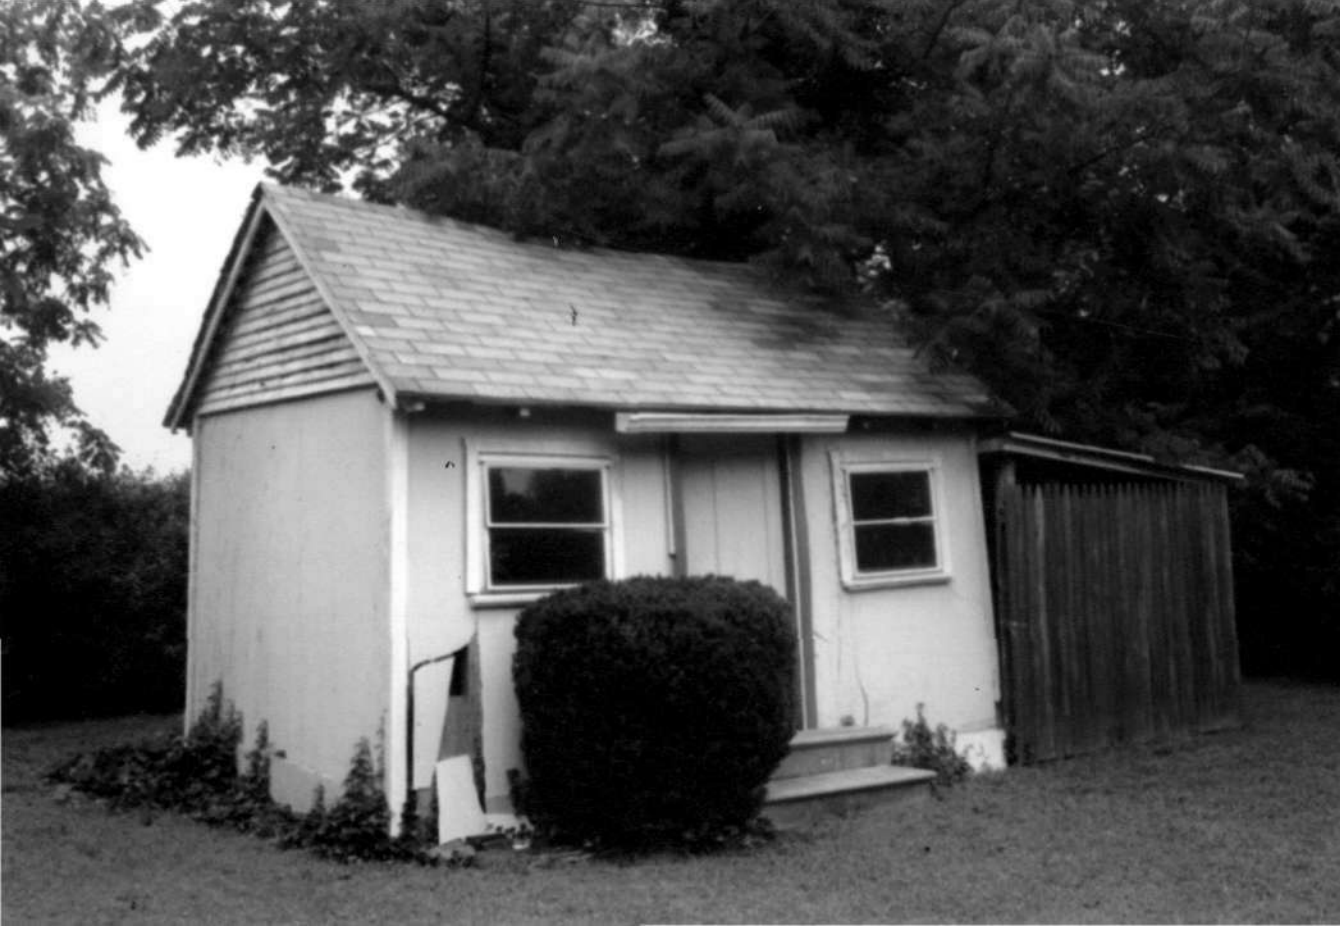
A circa-1930 frame shed is located to the northeast of the dwelling. The single-bay shed is rectangular in plan. The side-gable roof is clad with asphalt shingles, and rafter tails are exposed beneath the eaves. The exterior walls including the vehicle access doorway, are covered with particle board, and the gables are clad with weatherboard siding. A four-panel, wood, human-scale door

centered in the south elevation of the shed. The door is flanked by one-over-one light, vinyl-sash windows and is accessed by a set of concrete steps. The north elevation is covered by heavy foliage, and no openings are visible. The east elevation has no openings, and is abutted by a shed-roof lean-to. The lean-to has a standing-seam metal roof supported by wood posts. A section of wood fencing encloses the south side of the lean-to.

The shed no longer retains its original function and is in poor condition.

SHED, SOUTH-WEST elevations, looking NE
Photo # 7 of 12

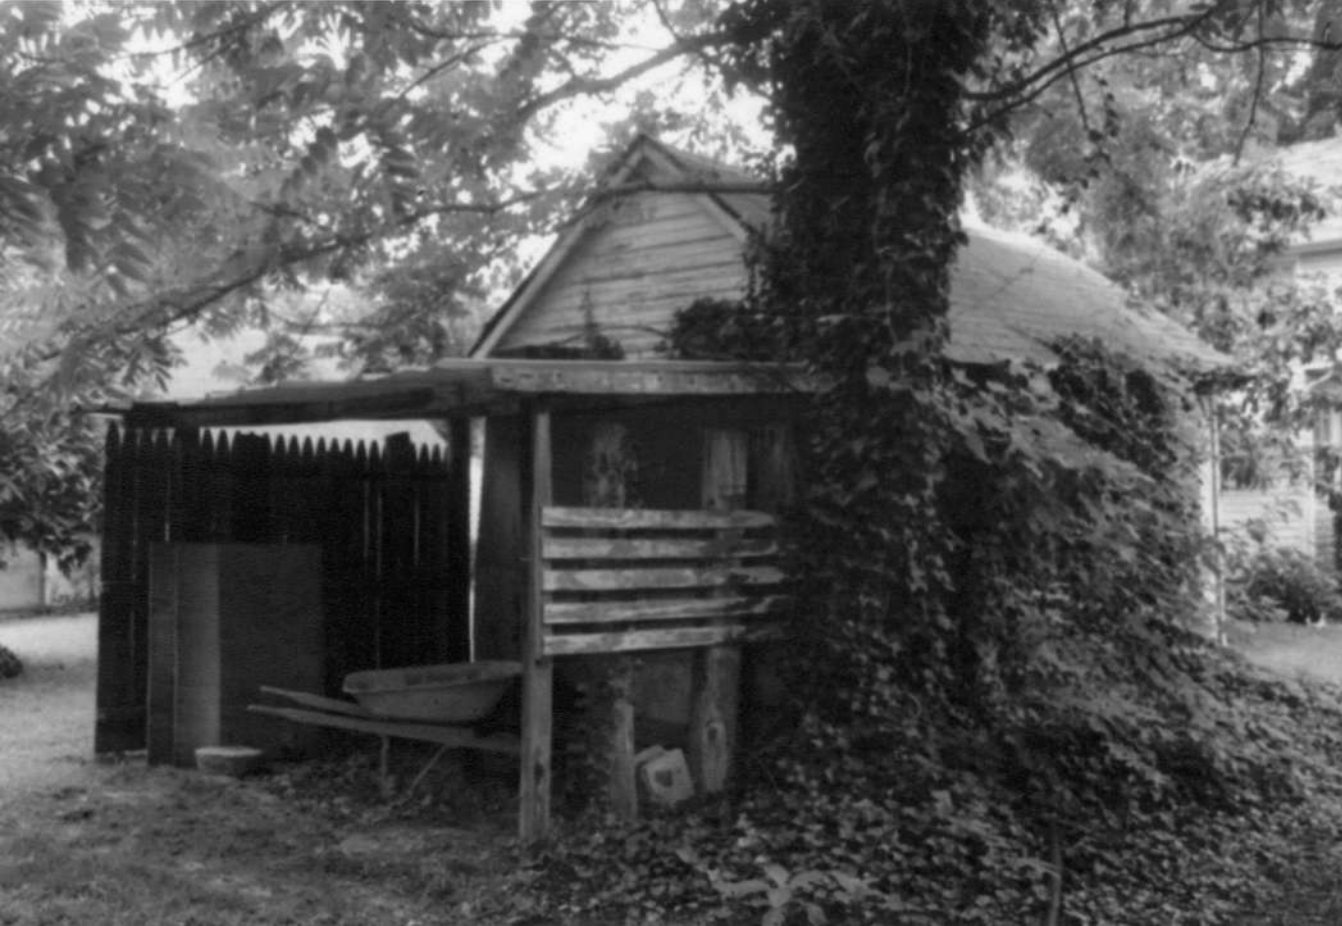
Photo # 8 of 12

SHED, NORTH-EAST elevations, looking SW

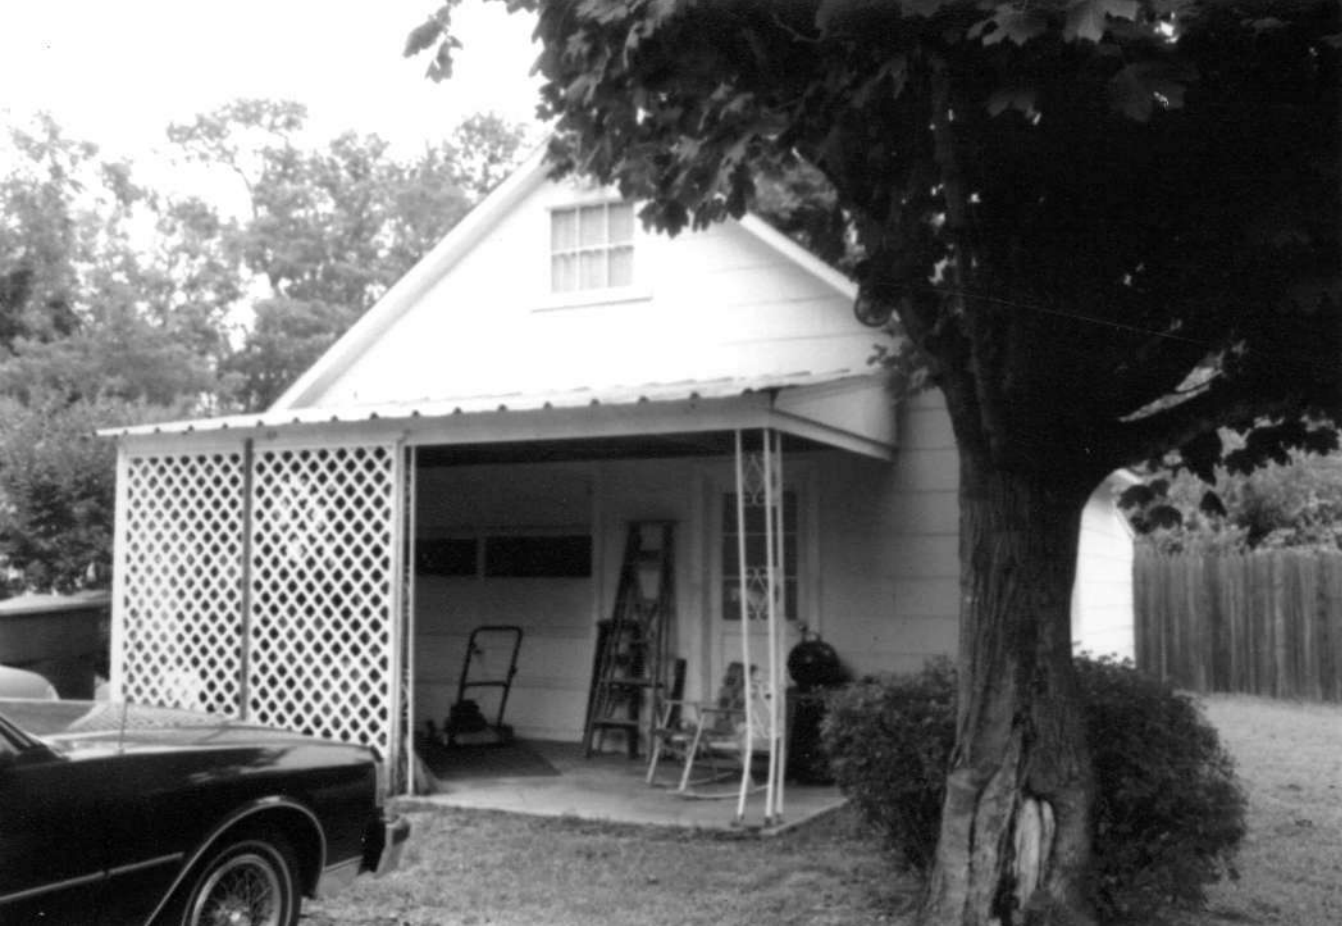
Photo # 9 of 12

A circa-1970, one-and-one-half-story, frame garage is located to the southeast of the dwelling. This garage was constructed by William McCrorey after he purchased the property in 1960 (personal communication, Joan McCrorey, July 9, 2008).

GARAGE (ca. 1970), WEST elevation, looking NE

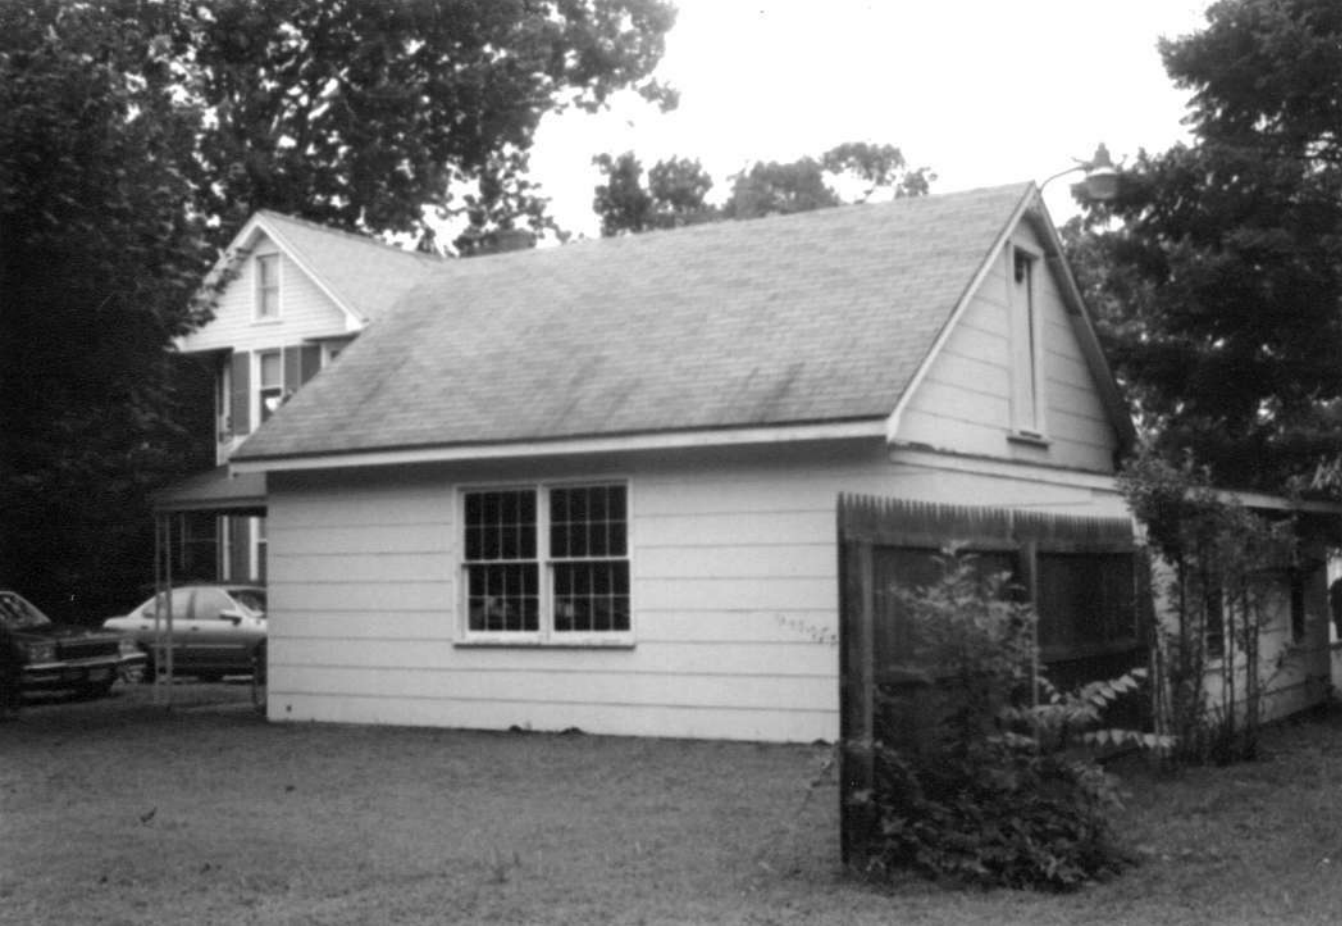
Photo # 10 of 12

GARAGE (ca. 1970), South & East elevations, Looking NW

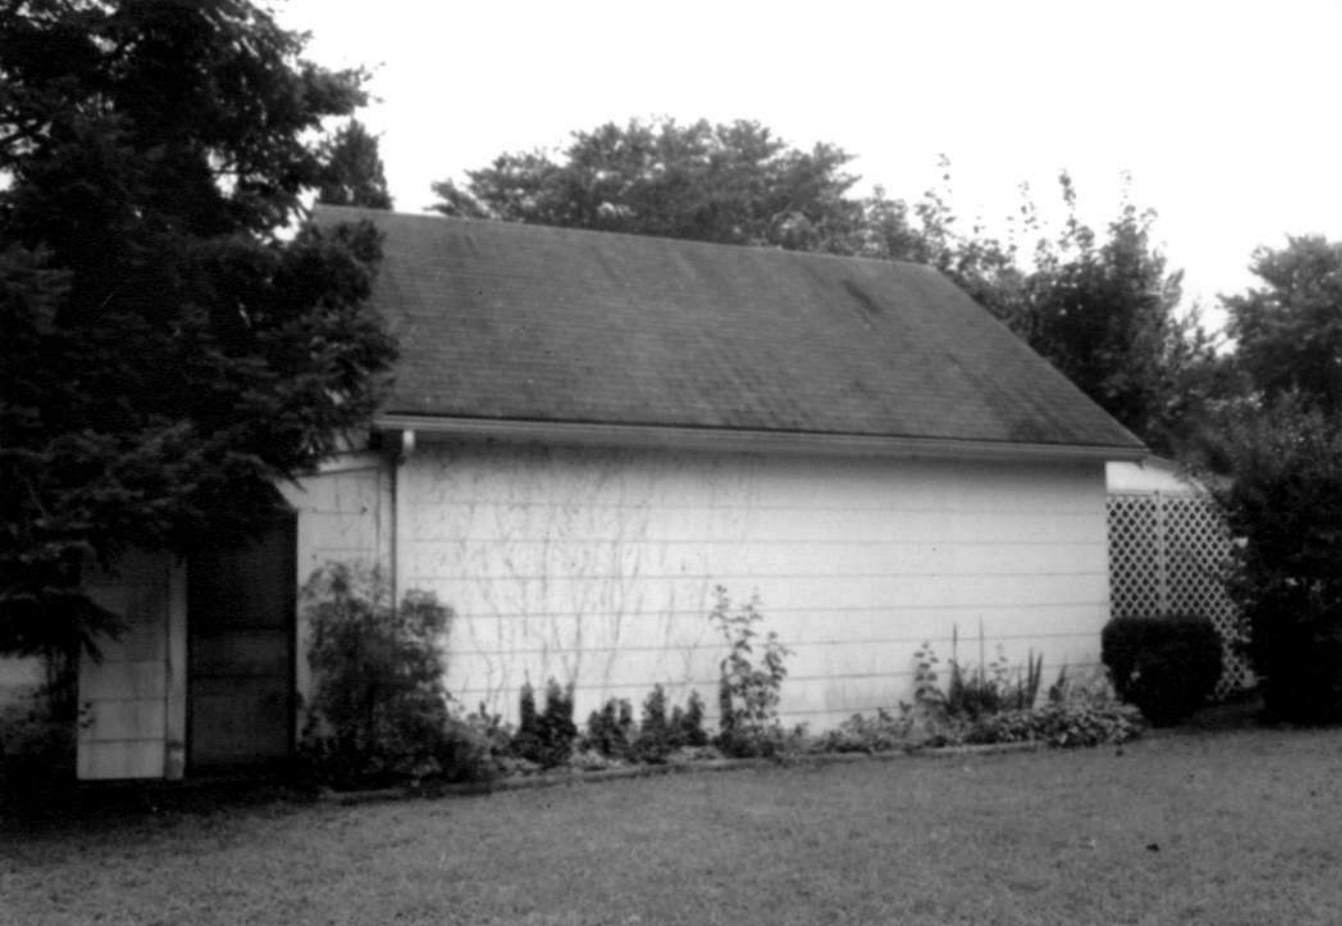
GARAGE (ca. 1970), north elevation, looking SW
Photo # 11 of 12

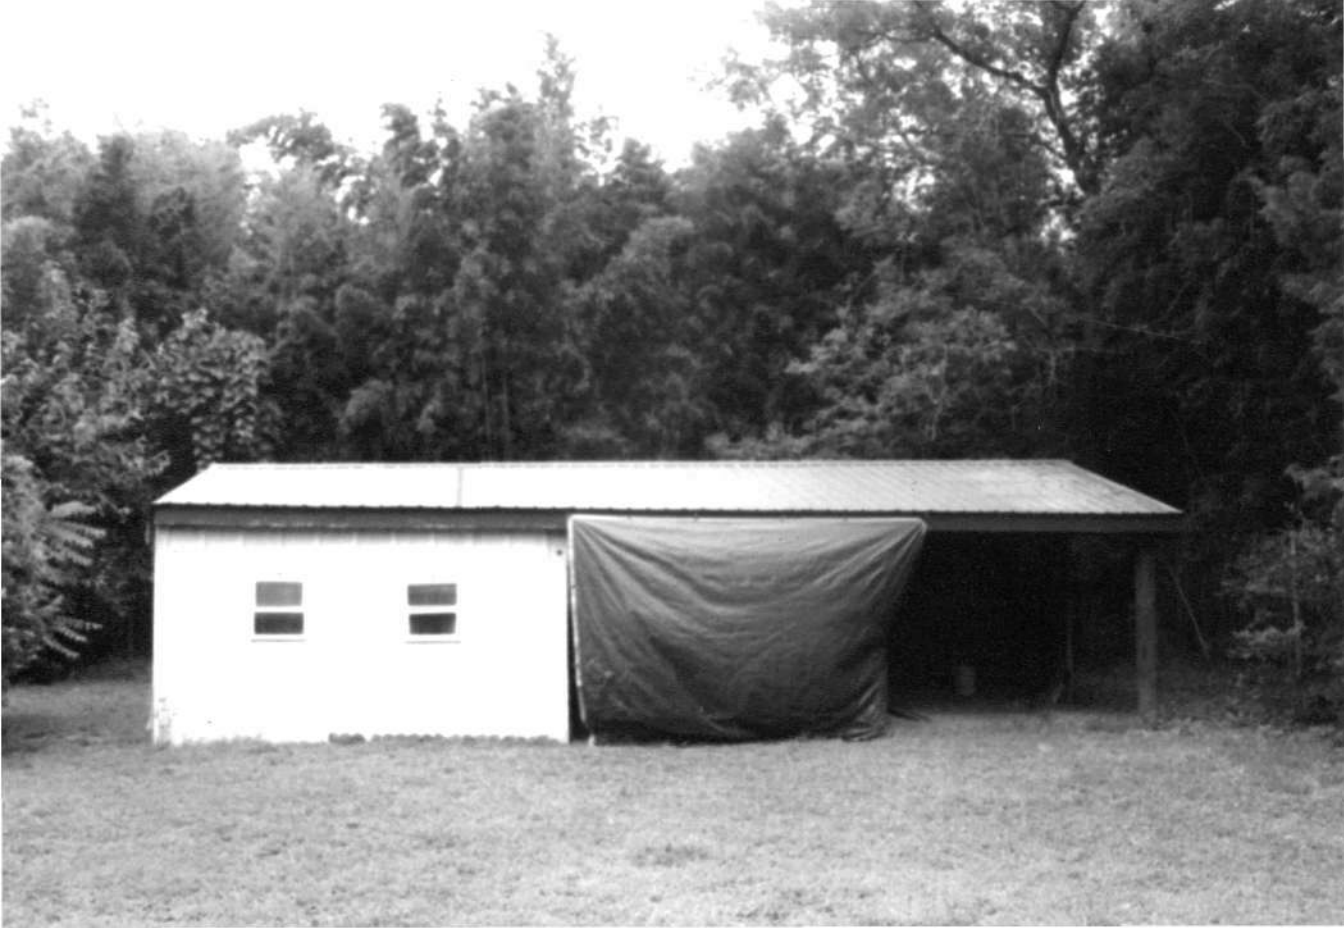
Photo # 12 of 12

A circa-1980, side-gable post-frame shed is situated to the southeast of the circa-1970 garage.

Post-Frame SHED (ca. 1980), west elevation, looking E
